CALIFORNIA DIVISION OF MINES AND GEOLOGY  
FAULT EVALUATION REPORT FER-237

**SPRINGVILLE, CAMARILLO AND RELATED FAULTS**  
in the Camarillo and Santa Paula Quadrangles  
Ventura County, California

by  
Jerome A. Treiman  
September 23, 1997

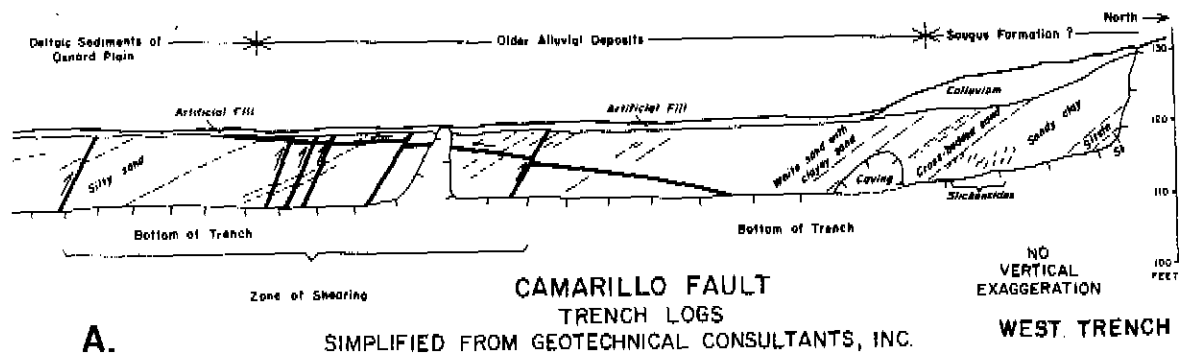
**Figure 8 (FER-237)** - Portion of Soil Survey (USDA, 1970) map 37 showing soils across the Camarillo and "Santa Rosa Valley" faults.

Jakes (1979) shows the fault south of the freeway and then bounding the southern side of the hill where Adolfo Camarillo High School is sited, but does not extend the fault eastward. This essentially follows the mapping of Ventura County (1975). Jakes points out that the hill on which the school is sited is probably the eastern continuation of the ridge to the west, having been eroded in between by Calleguas Creek. Both are mapped by Jakes, as well as other workers, as being underlain by older alluvium. Along the trend of the fault, a 10-foot high step in the flood plain parallels and underlies the freeway (Blake, 1991). The upper deposits of this flood plain, about one mile to the northeast, are probably Holocene in age (Staal, Gardner & Dunne, 1988; Geolabs-Westlake Village, 1990c; Shlemon, 1990). The soils on this surface, both north and south of the scarp, consist of young loam, loamy sand, and sandy loam with an A/C soil profile (USDA, 1970; see Figure 8 herein).

In the flood plain immediately to the east of the ridge, a small drainage (possibly man-induced) used to cross the projection of this inferred fault (1938 photos AXI-18-95&96). Although no scarp was discernible, the drainage changed from an eroding channel, north of the fault projection, to a depositional drainage to the south. Earlier photos (Fairchild, 1927, C104, K18&K19) indicate a possible scarp or tonal lineament at this location. Continuing eastward, the fault appears to step left (northward) to a gentle, curvilinear bench in the Calleguas Creek flood plain, a bench that is now occupied by the 101 Freeway. Although not visible in the aerial photos, the 1950 topographic base map (1:24,000) reveals the early stages of a fan/levee complex where Calleguas Creek debouches from the step in the flood plain. The north-south elongate nature of this deposit suggests that there has not been sufficient time for it to develop a full fan shape. A somewhat broader, young fan is also suggested by the distribution of soil unit MeA on the USDA (1970) soil map (see Figure 8).
